Secretary of the Interior's Guidelines for the Treatment of Historic Storefronts

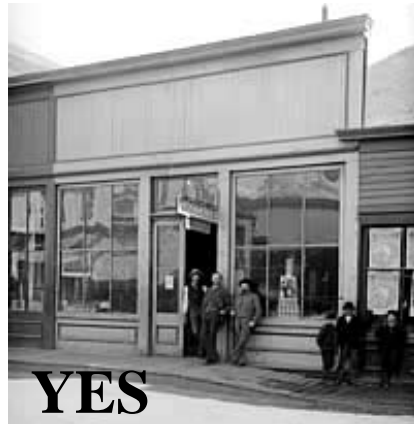
An example of using a historical photo to guide a restoration project (Photo: Library of Congress)

- Re-creating a missing storefront or storefront feature that existed during the restoration period based on physical or documentary evidence; for example, duplicating a display window or transom.

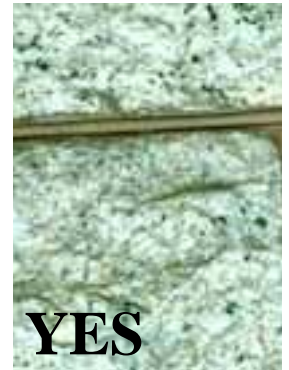
Late 19th century granite that has been repointed with the original joint profile and mortar color. (Photo: NPS files)

- Repairing masonry walls and other masonry features by repointing the mortar joints where there is evidence of deterioration such as disintegrating mortar, cracks in mortar joints, loose bricks, damp walls, or damaged plasterwork.

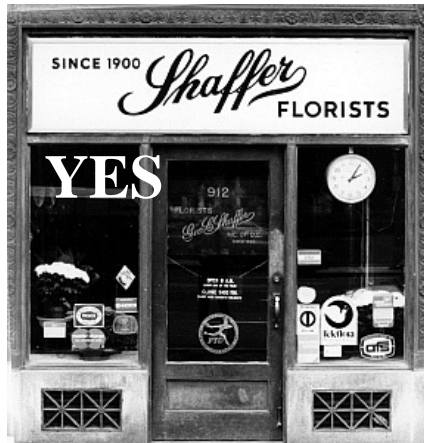
An example of a 1920s storefront retained through preservation. (Photo: David W. Look, AIA.)

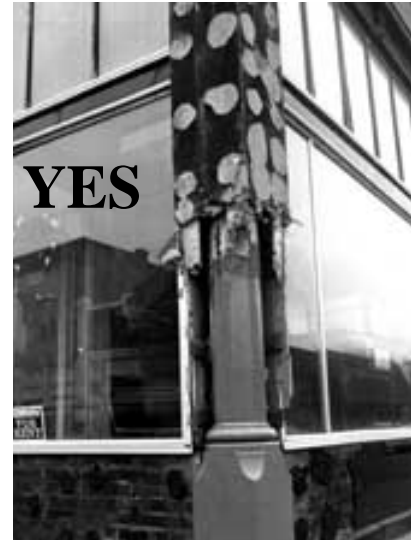
Removing a metal grid installed over an original facade. (Photo: Bob Dunn, NPS)

- Removing or altering storefronts and their features from other historic periods such as inappropriate cladding or signage.

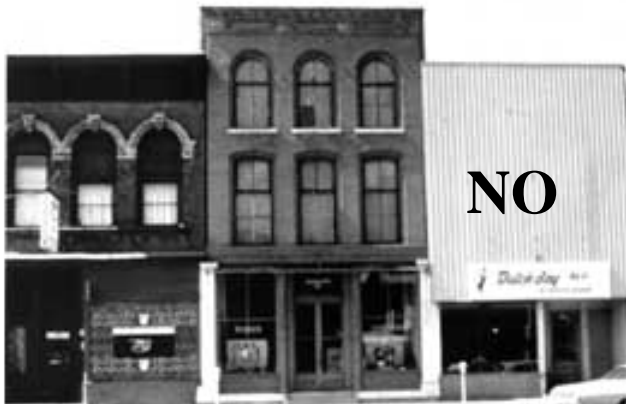
Impact of inappropriate alterations on historic storefronts (the storefront on the right has been totally obscured by a "modern" front added in the 1950s. Photo: NPS files)

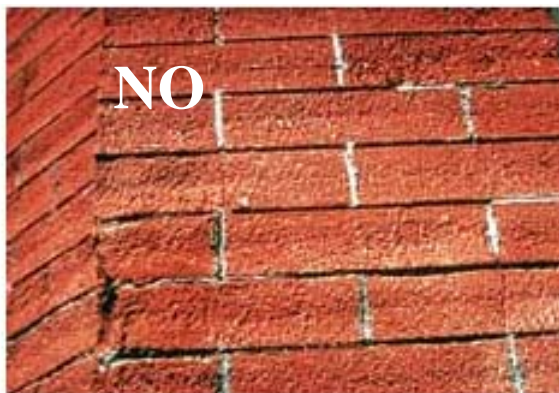
Abrasive cleaning methods, in this case sandblasting, can permanently damage building surfaces. (Photo: NPS files)
